LONG-TERM PERFORMANCE OF THE FIRST REINFORCED EARTH WALL IN CALIFORNIA

FINAL REPORT
AUG, 1980

1. REPORT NO. FHWA/CA/TL-80/27		2. GOVERNMENT ACCESSION NO.		3. RECIPIENT'S CATALOG NO.	
4. TITLE AND SUBTITLE LONG TERM PERFORMANCE OF THE FIRST REINFORCED EARTH WALL IN CALIFORNIA				5. REPORT DATE August 1980

LONG TERM PERFORMANCE OF THE
FIRST REINFORCED EARTH WALL
IN CALIFORNIA

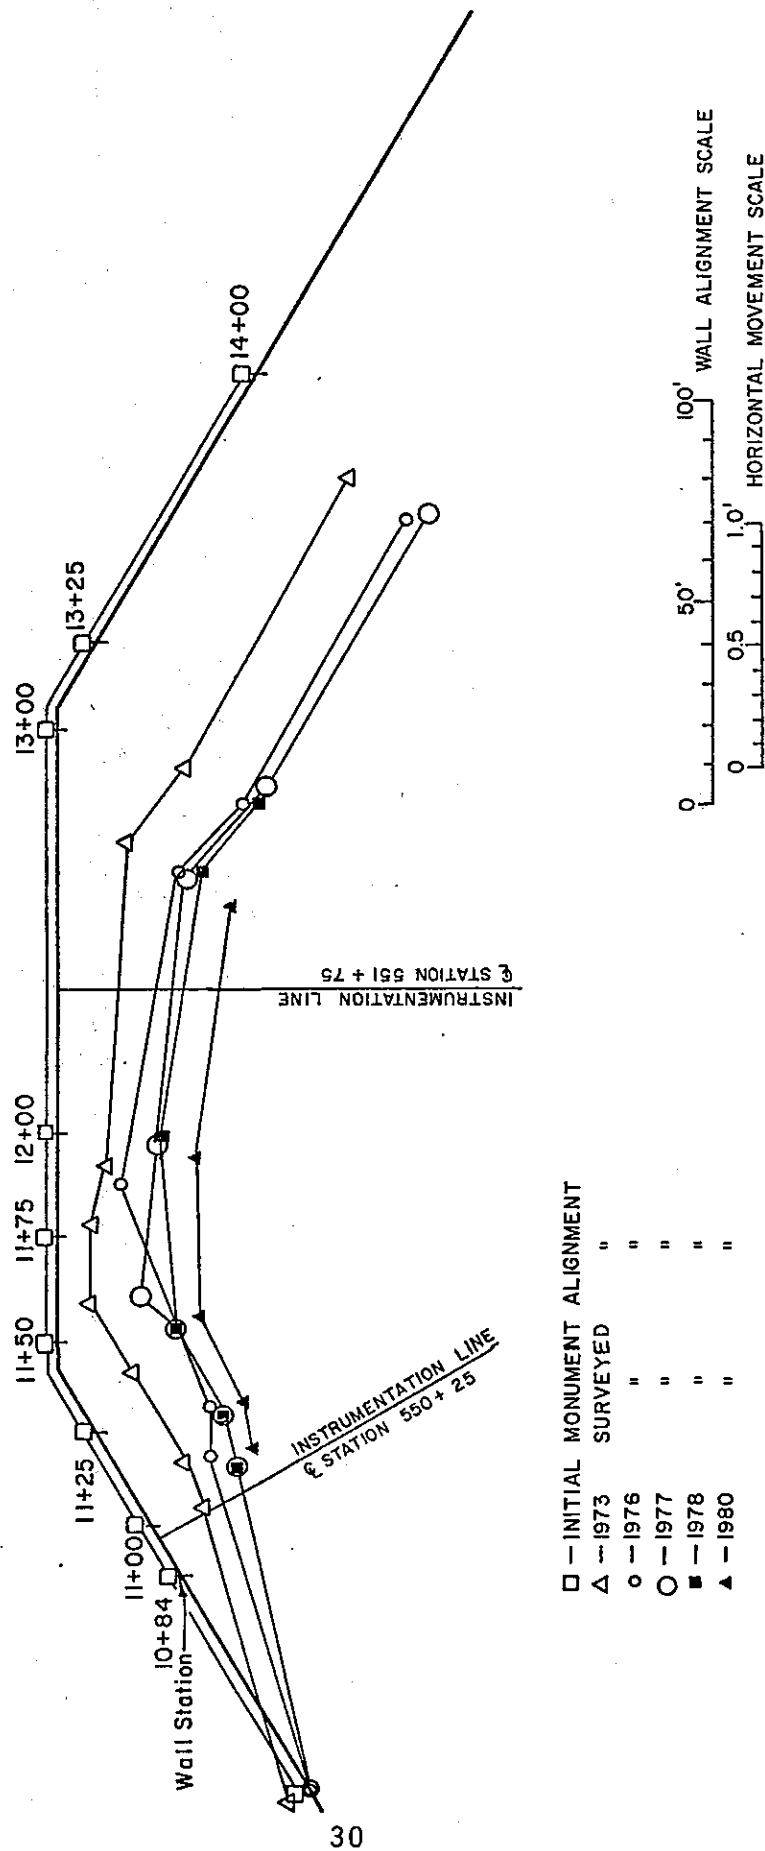
FIGURE 11

Measurements made on Series "C" monuments on top of the wall suggest 1.5 to 1.9 inches of additional horizontal movement since 1978 for the north flank and center chord sections of the wall. (Refer to Figure 11 and Table 6.) These measurements represent horizontal movement since 1978, the majority of which probably occurred prior to the correctional work in 1979. The measurements, therefore, do not provide a good assessment of the effectiveness in correcting the overall stability of the wall.

The maximum total recorded horizontal movement was 12.48 inches on May 5, 1980, and also occurred at Sta. 13+00.

HORIZONTAL MOVEMENTS AT SERIES "C" MONUMENTS

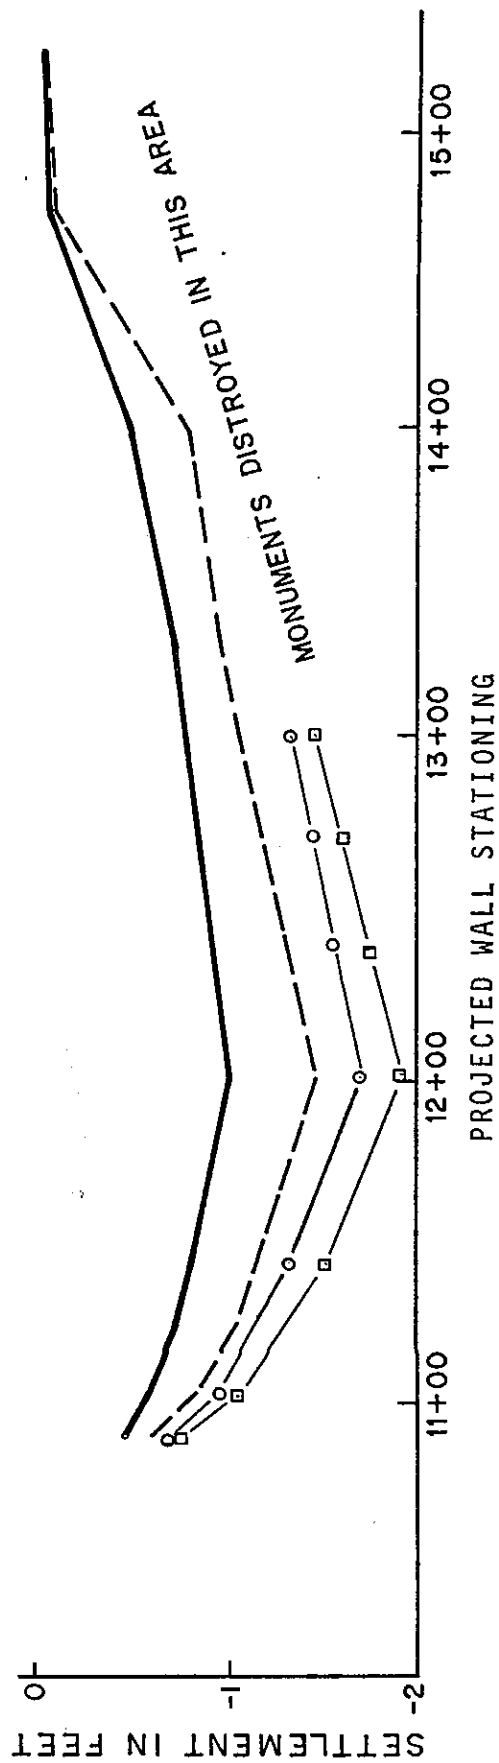
FIGURE 13

Settlement of the wall has continued since construction. A total settlement of 3.5 ft was recorded on settlement platforms SP1 through SP4 at Sta. 551+75, Level A, through December 1973. (Refer to Figure 8.) The readout at this level was destroyed after that date. Measurements on Series "A" and "C" monuments have provided a continuation of the settlement record. Based on these measurements, about 1.0 ft of additional settlement has occurred through May 1980. Measurements on Series "A" monuments show a maximum of 0.5 ft of settlement between 1973 and 1978 (Figure 12). No settlement measurements are available for Series "A" monuments after 1978 since they were buried by the correctional work. Series "C" monuments at the top of the wall suggest a maximum of 1.0 ft of settlement between 1973 and May 1980 (Figure 13). About 20% of that occurred since 1978.

SETTLEMENTS AT SERIES "C" MONUMENTS

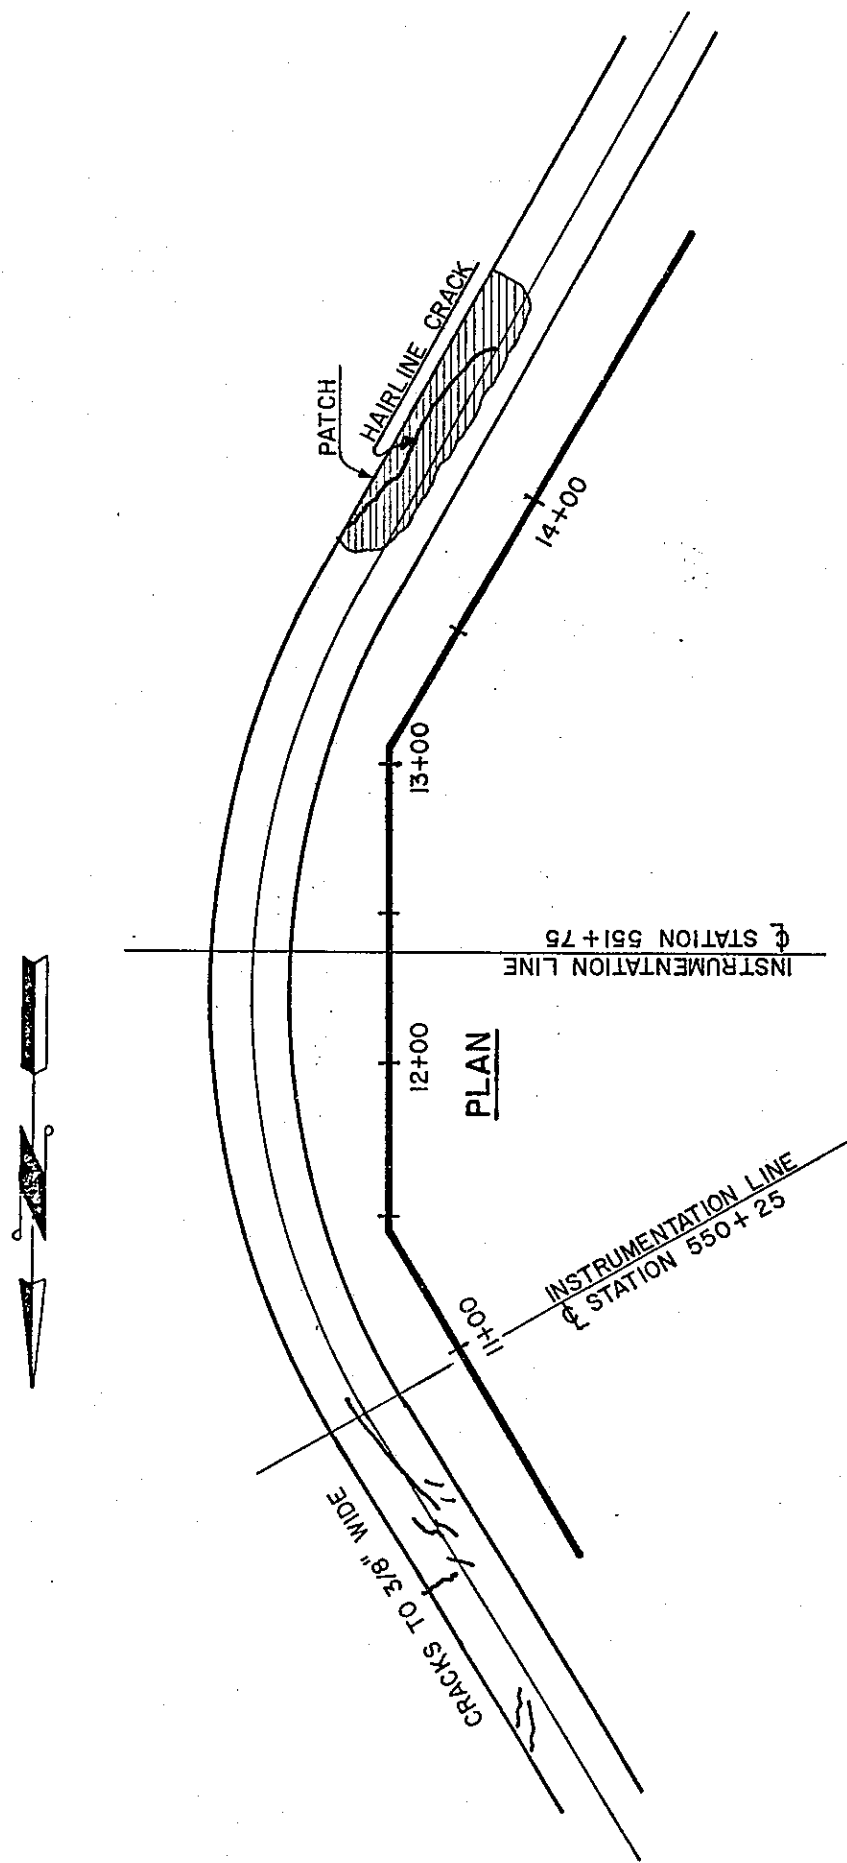
FIGURE 14

A crack count made during the final condition survey indicated several 1/4 to 3/8 inch wide cracks in the pavement behind the north flank of the wall. These are shown in Figure 14 and are the same cracks observed in 1978 (Photo 10). Hairline cracks were also observed in the patched pavement area behind the wall's south flank (Photo 28). These cracks were reflecting up from the interface between the patch and the old pavement. The pavement and roadway above the wall are otherwise in excellent condition.

PAVEMENT CONDITION STUDY, JUNE 1980

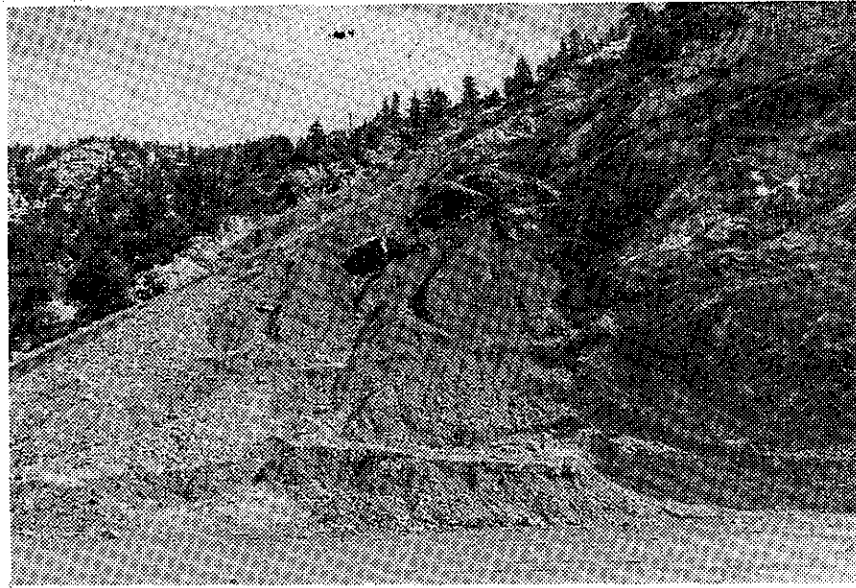
Photo 3 - Continuous Accumulation of Slide Debris Behind Wall

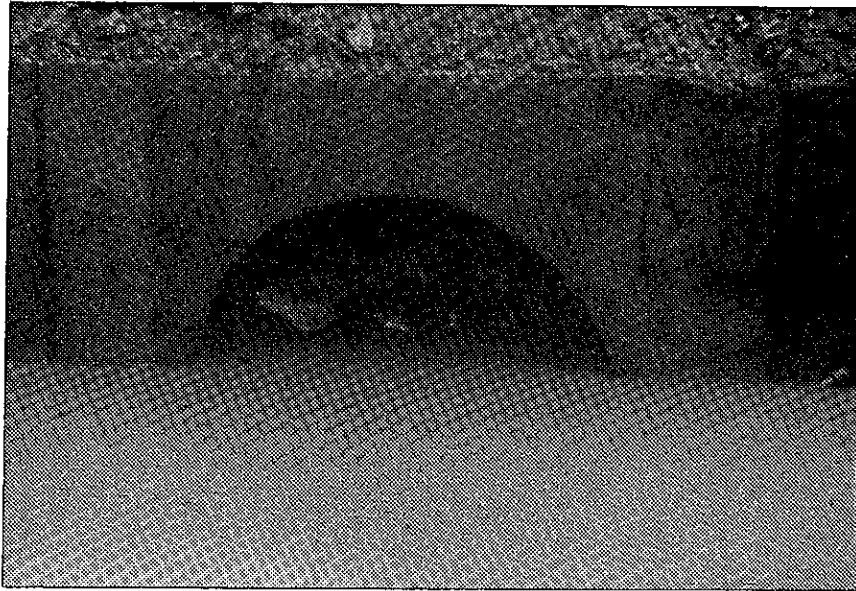
to surface water moving directly into the highly permeable embankment from natural drainage swales in back of the wall, when these flows were unable to reach the culvert inlet (Photo 4) or due to a plugged inlet structure (Photo 5).

Photo 5 - Plugged Culvert Inlet During
Winter Storm

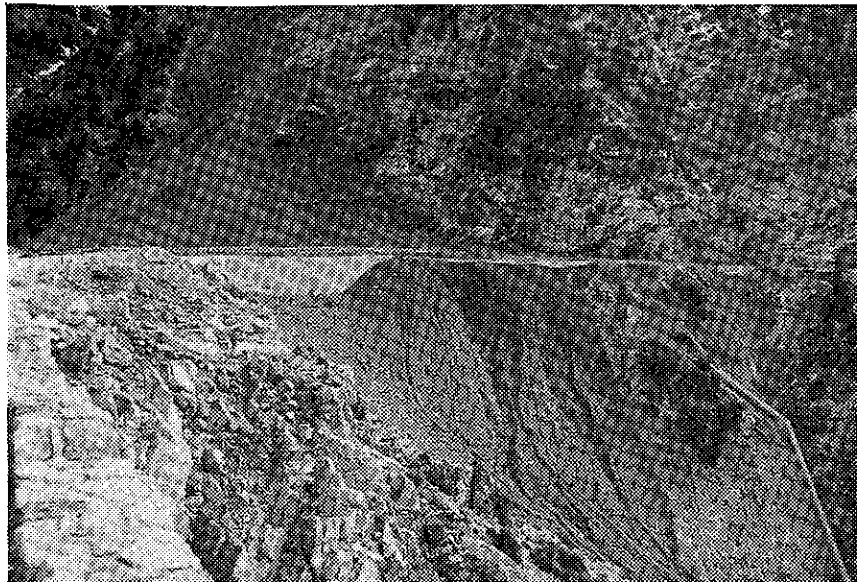
The primary area of concern was along the south flank where strain gage instrumentation and reference points indicated continuing outward movement. Approximately 50,000 cu. yds. of material were pushed over the wall face and down the slope during November and December 1977 (Photo 7). This remedial measure provided temporary buttressing through the winter of 1977 at a fraction of the cost for the proposed engineered (compacted) slope correction. However, during the winter of 1977-1978, erosion occurred on the temporary buttress which steepened the slope and based upon a stability analysis reduced the factor of safety (Photos 8 and 9).

Photo 8 - Erosion on Temporary Buttress
(Winter of 1977)

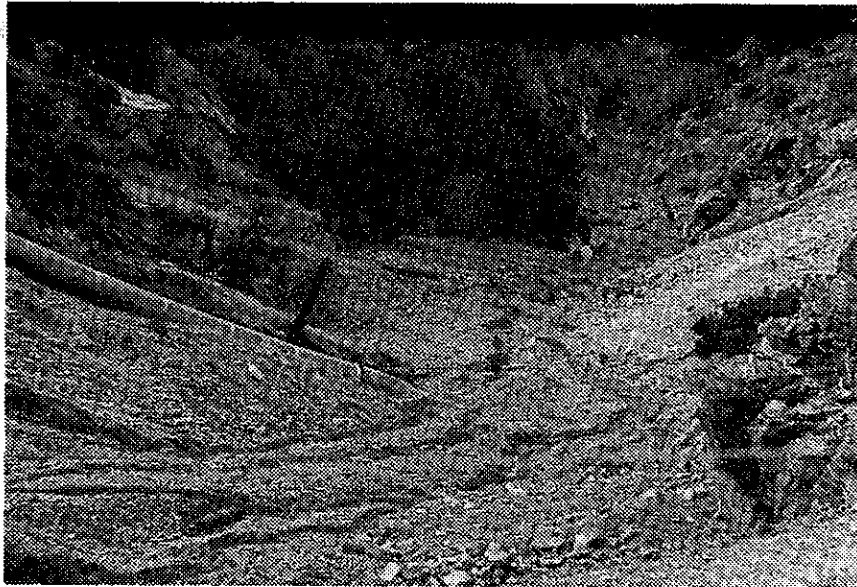
Photo 9 - Erosion at Toe of Slope Below
Wall (June 1978)

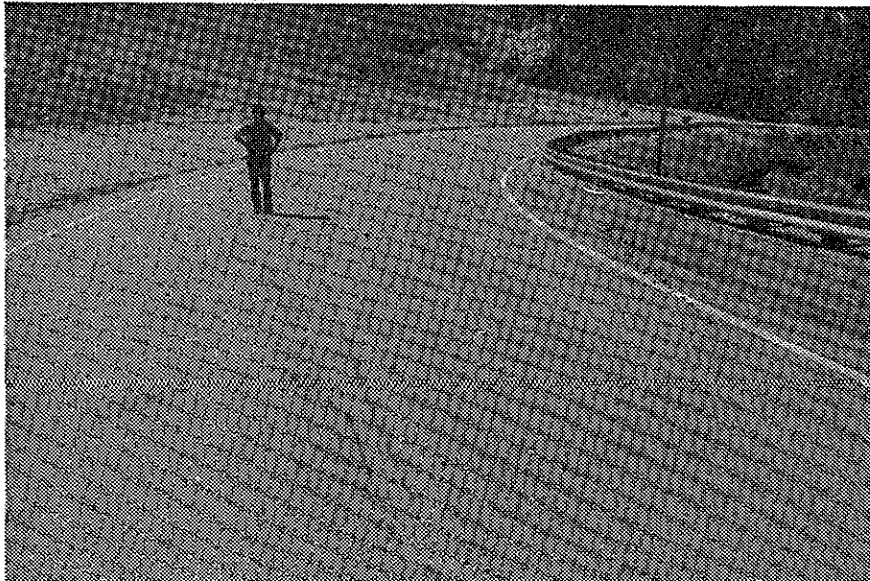
During this period, a series of cracks appeared in the pavement on top of the north flank of the wall near roadway

centerline for a distance of about 40 feet (Photo 10). It was apparent that reshaping of the slope below the wall would be mandatory prior to the next winter season. Recommended remedial measures by the Transportation Laboratory to improve wall stability were submitted to District 07 in October 1978. These measures included flattening the embankment slope, interception and diversion of surface runoff and removal of additional slide debris behind the wall plus repair of the drain system below the wall.

Photo 10 - Cracks in Pavement at North Flank
of Wall Near Centerline (June 1978)

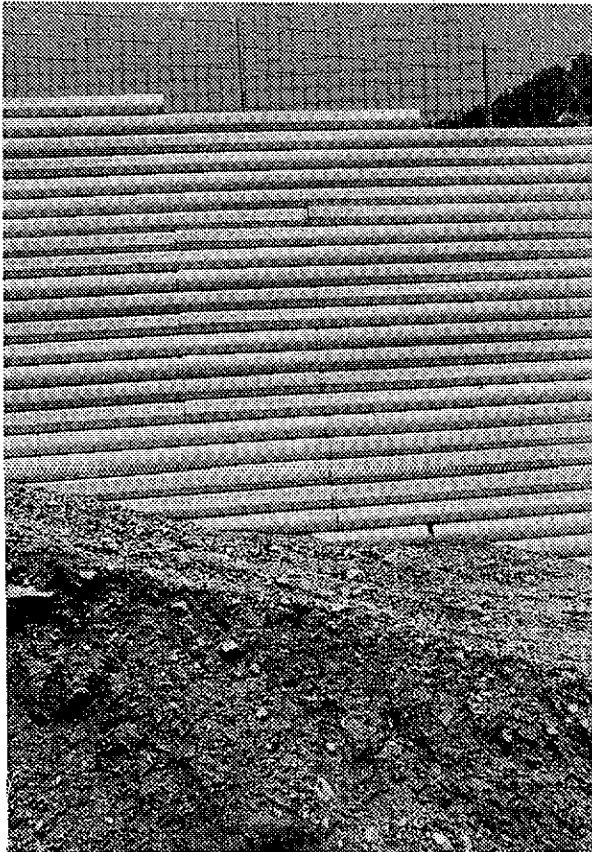
The relative magnitude and direction of movement of the wall has been manifested in the steel face elements as shown by photographs taken June 28, 1980. Photos 22, 23 and 24 show the extension and separation at the joints between skin plates on the north flank due to axial tensile stresses in the face. (Refer to skin element numbers 46, 57 and 69 in Tables 7 and 8.) This condition also occurs but to a lesser extent at the end of the south flank.

Photo 22 - Extension and
Separation of Skin Plate
Joints on North Flank
(May 1980)

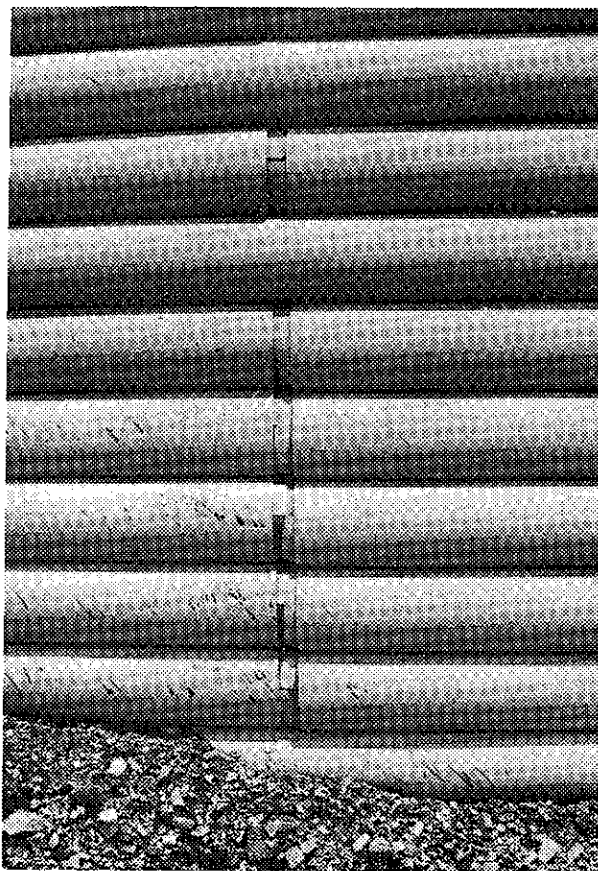
Photo 23 - Close-up of Skin
Plate Joint Separation on
North Flank (May 1980)

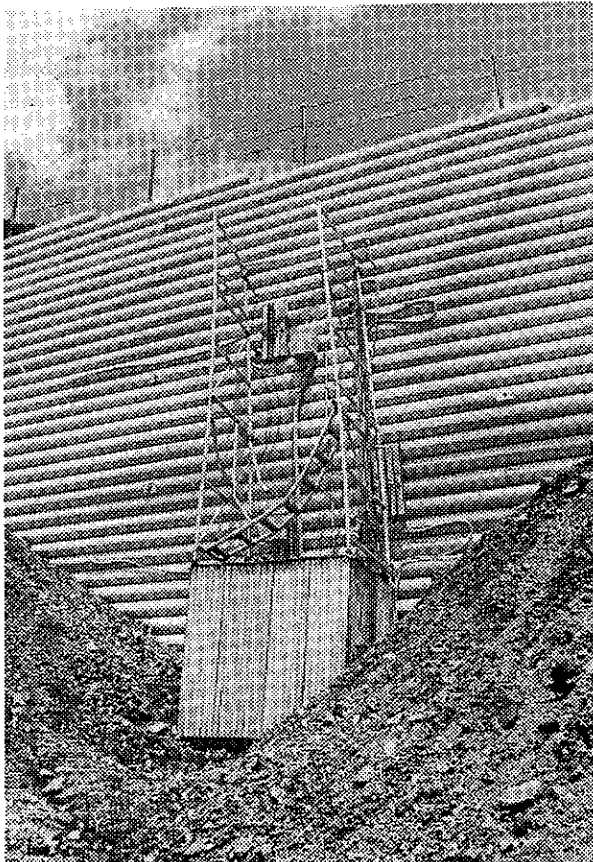
Photo 24 - Skin Plate Joint
Separation Near Instrumenta-
tion Station 550+25, North
Flank (May 1980)

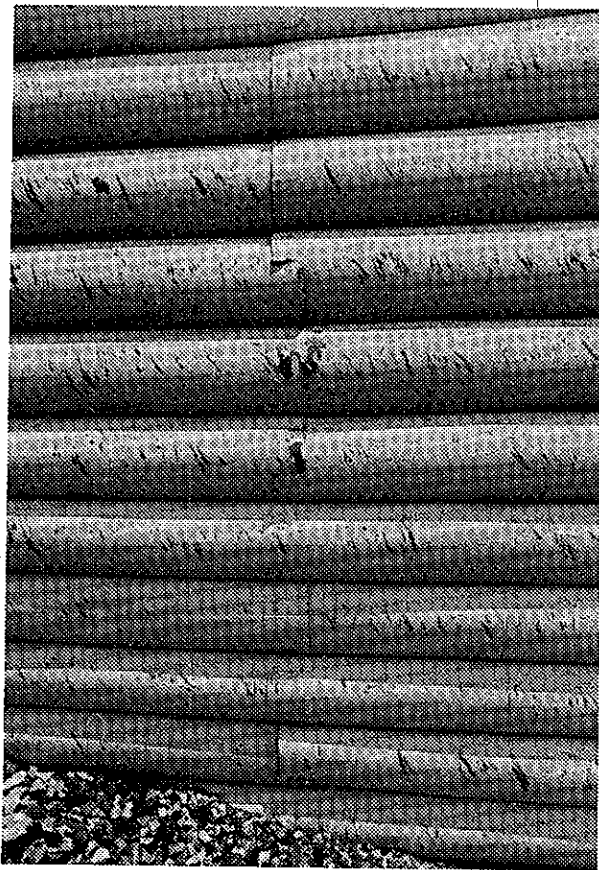
Photos 25 and 26 show the effects of the tremendous axial compressional forces that have been experienced by the center chord of the wall due to a buildup of lateral forces as the wall has moved outward. Note the distortion and gouging of end plates that has occurred. (Refer to skin element numbers 8, 25 and 43 in Tables 7 and 8.)

Photo 25 - Close-up of Skin Plate Joint Compression in Center Chord (May 1980)

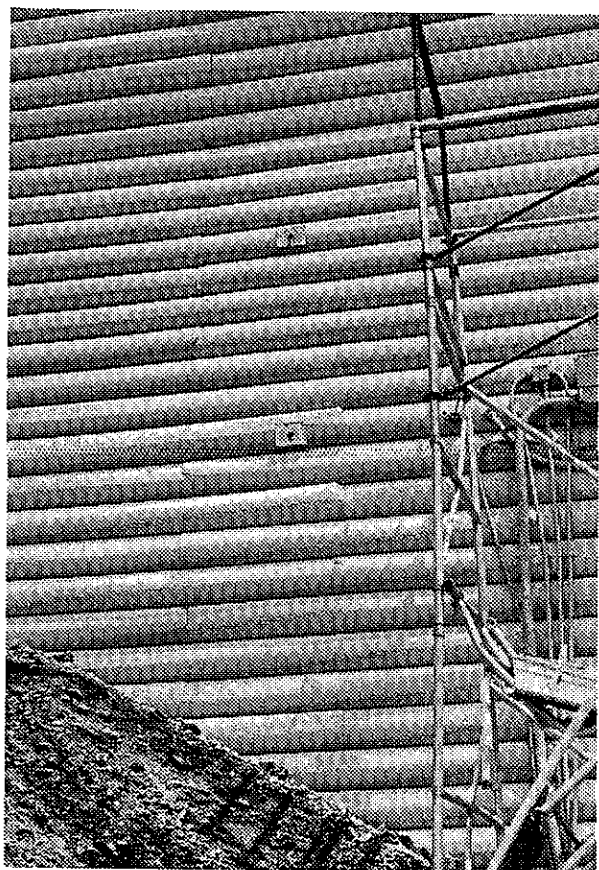
Photo 26 - Evidence of Skin Plate End Gouging and Distortion Near Instrumentation Station 551+75, Center Chord (May 1980)

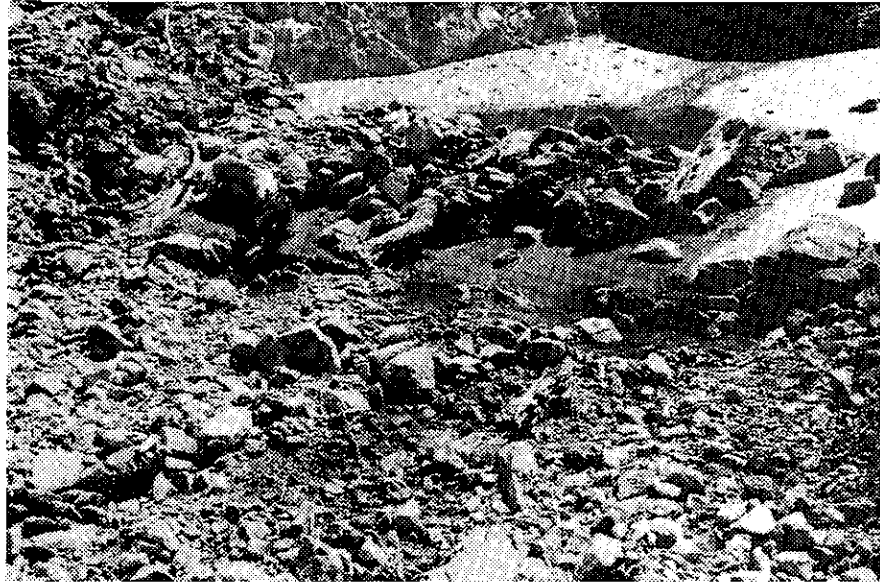
A final condition survey was obtained on June 12, 1980. It was noted that an estimated stream flow of about 5 gal./min. of water was coming down the slope behind the wall and entering the upper portion of the drainage channel (Photo 27). This flow disappeared into the channel about 3 ft. beyond a concrete lined approach apron. It was apparent therefore that the drainage correction was not completely satisfactory since none of this flow was reaching the culvert inlet. However, the drainage facility was in excellent condition considering the 35 inches of rainfall that occurred this past winter season since the channel was repaired.

Photo 27 - Water Flowing into Drainage Channel
Behind Wall and Disappearing Rapidly
into Pervious Channel (June 1980)

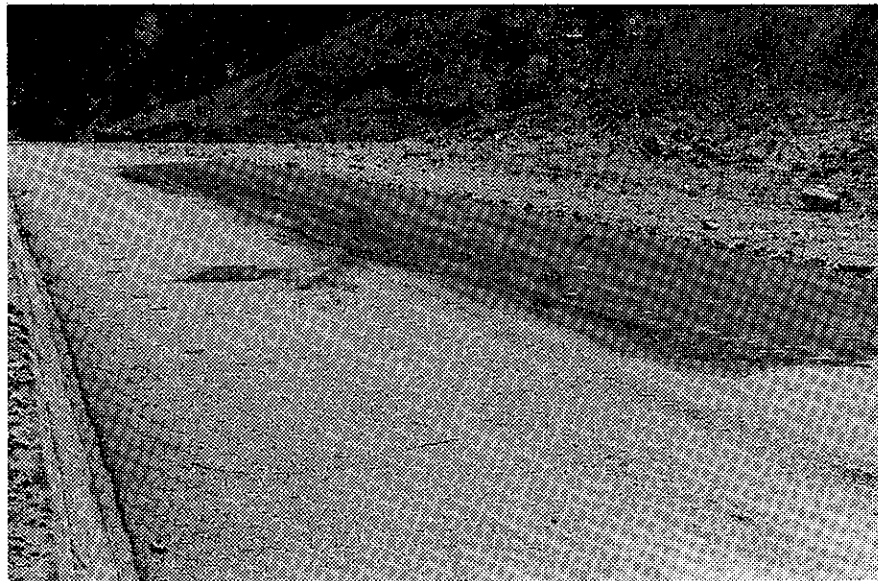
personnel below the pavement surface near the south flank of the wall above the pervious sand blanket behind the reinforced earth wall. (See Figure 1 Profile.) Maintenance forces were requested to identify the extent of the cavity and backfill it with either pea gravel or jetted sand. This would be followed by sealing the roadway surface with asphalt concrete to prevent infiltration of surface water. Maintenance elected to jetty sand into the cavity, which on observation appeared to provide a satisfactory repair. A similar crack was repaired in the same area during the spring of 1973.

Photo 28 - Patched Pavement Behind South Flank
of Wall (June 1980)

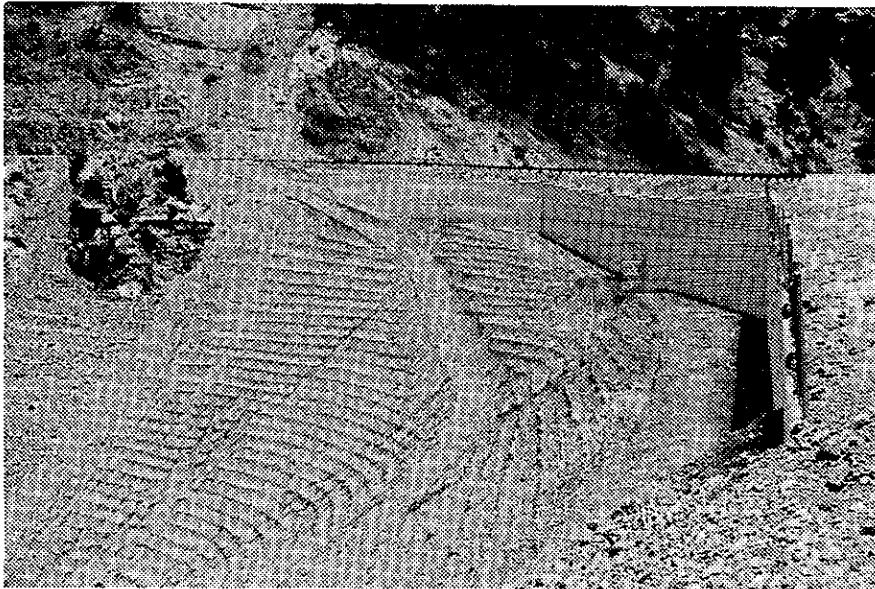
The fill slope below the wall is in generally good condition with some surface erosion (Photos 29 through 31), most of which has occurred at the south end of the wall below a rock outcrop. Erosion is concentrated in this area due to surface water runoff over the rock face.

Photo 29 - Side View of Wall Looking North at
Access Road on Slope, After One
Rainy Season (May 1980)

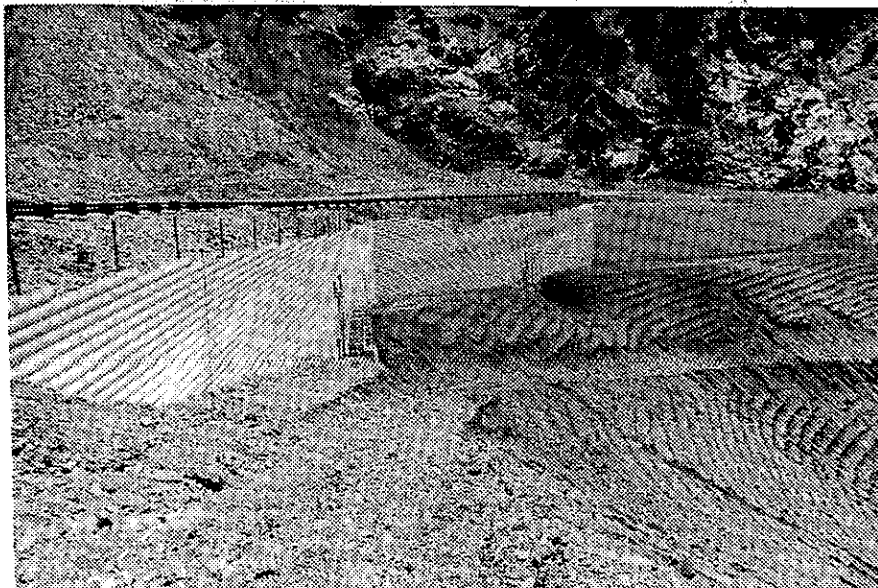
Photo 30 - Side View of Wall Looking South at
Access Road on Slope, After One
Rainy Season (May 1980)

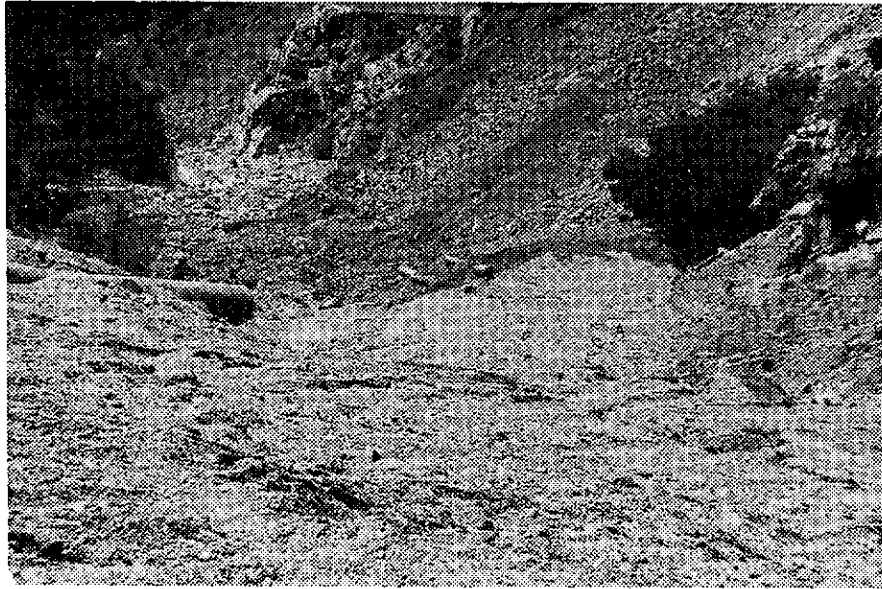
Photo 31 - Catchment Basin at Toe of Slope with Retained Eroded Material, After One Rainy Season (May 1980)
